# EVALUATION OF PROTECTIVE COATINGS FOR CONCRETE

December, 2004 Final Report

County Sanitation Districts of Los Angeles County, Whittier, California

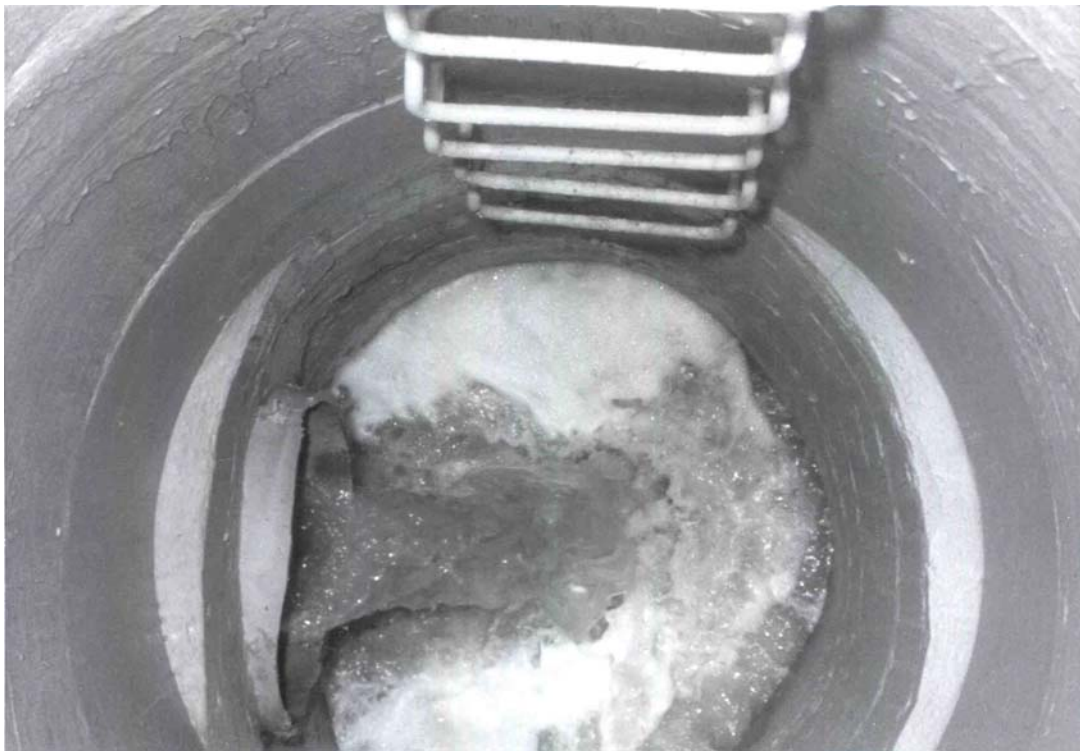
Figure 1A. Urethane coating applied to a drop manhole.

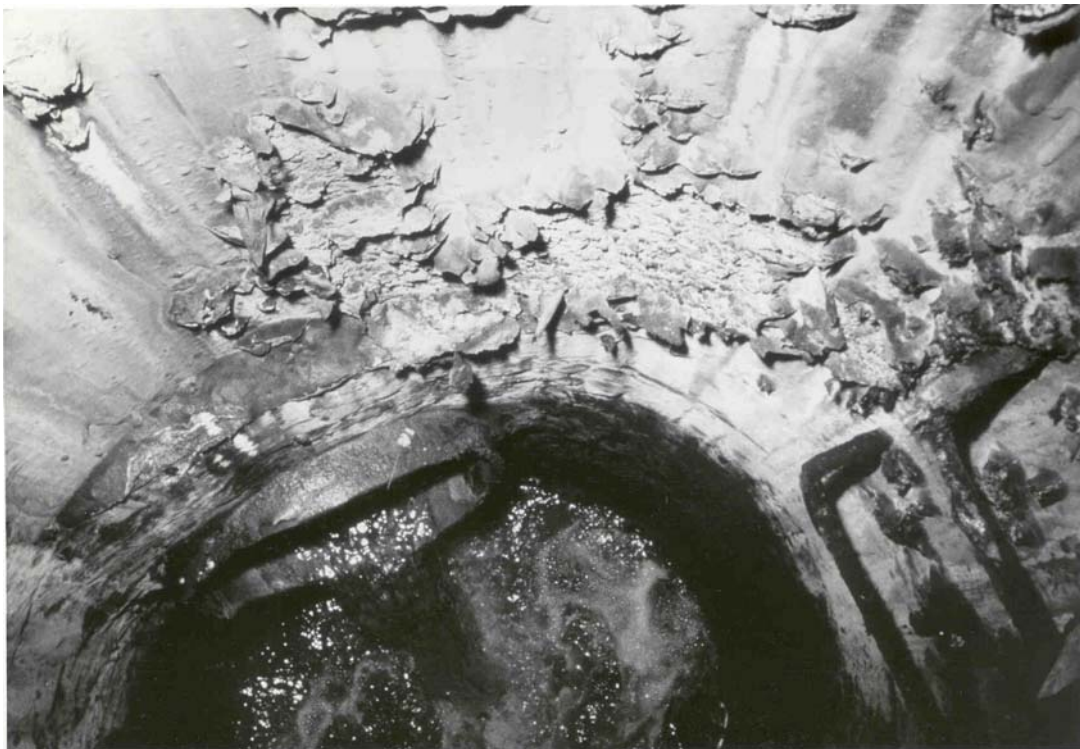
Figure 1B. Urethane coating failure after two years.

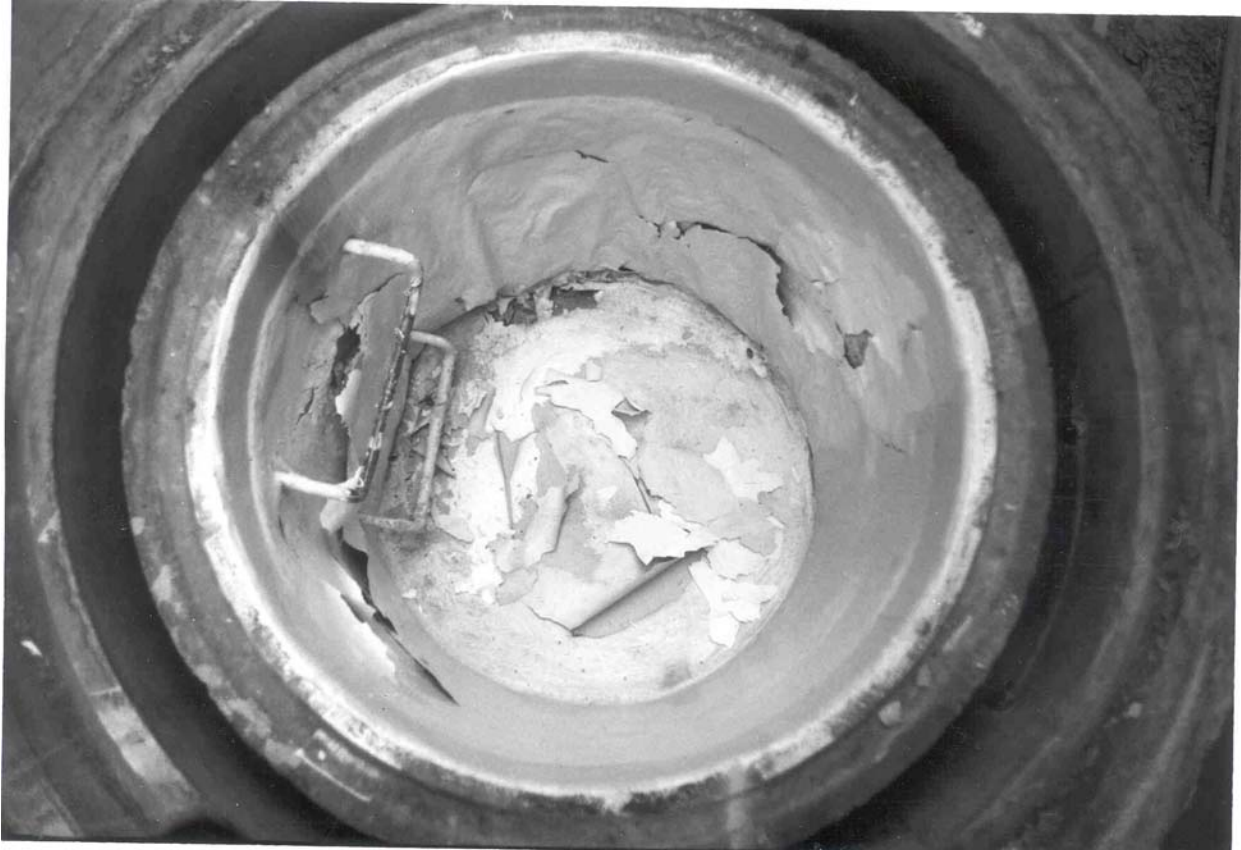
Figure 7 illustrates the coating failure that occurred after only a short time period to one epoxy coating (C-7). Preliminary tests with ingots of one system (C-23) looked promising, but the manufacturer decided to use a non-epoxy coating system in the evaluation. Lack of sufficient acid resistance and inability to protect the concrete from corrosion plagued the other systems (C-14, C-19, and C-21).

Figure 7. Epoxy coating failure.

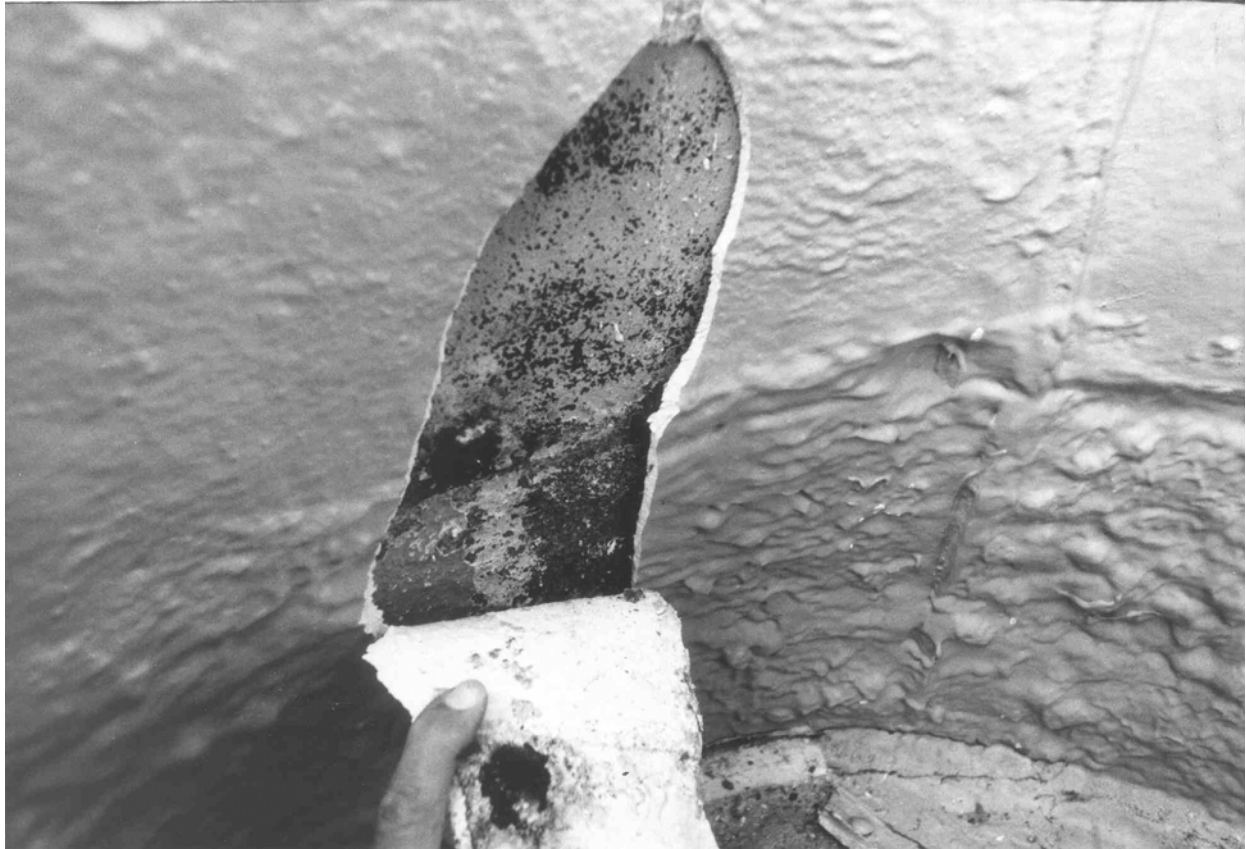
C-48, C-52, C-60, C-71, and C-92) were resistant to sulfuric acid, but only two coating systems (C-10 and C-71) provided a tenacious bond to the concrete substrate, and a relatively pinhole free surface.

Figure 8. Section of urethane coating pulled from a test tank wall.
