Zero (VOC) Structural Epoxy Rehabilitation of Steel and Concrete Tanks, Pipes and Structures

Danny R. Warren
Warren Environmental, Inc.
P.O. Box 1206
Carver, MA 02330

FOCUS PROJECT #1

FOCUS PROJECT #2

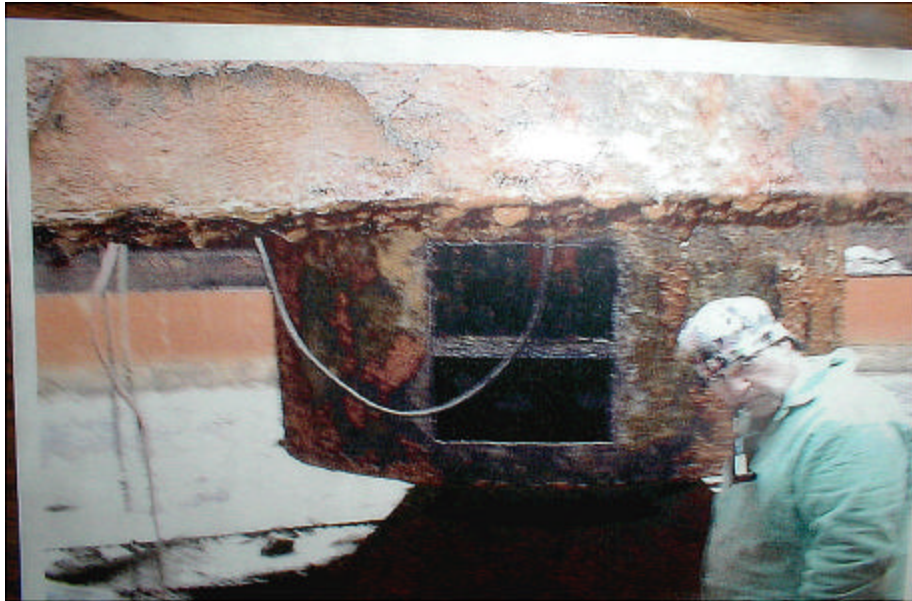
Center Flume of Raw Water Treatment Tank

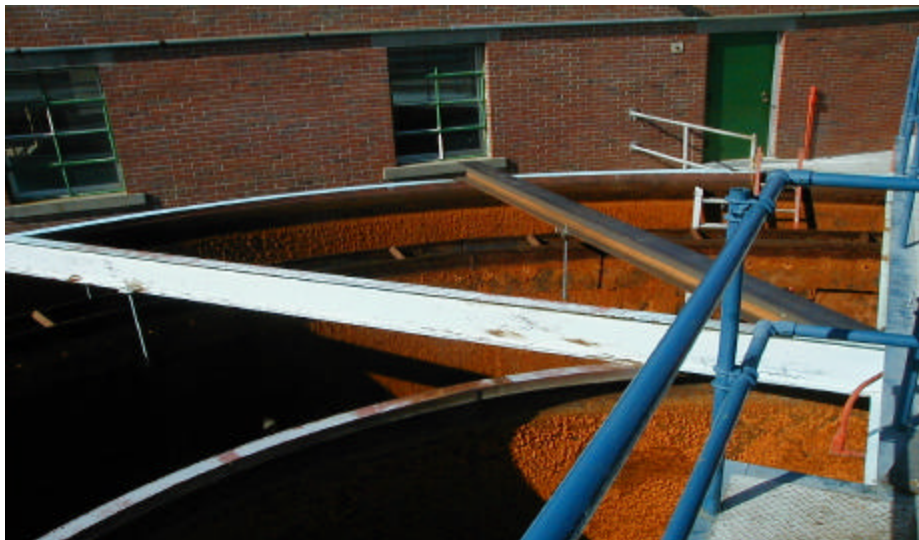
years ago. The interior had never been lined. According to Robert Ganley, the consulting engineer on the project, the tank had been equipped with a cathodic protection system at one time, but it apparently never operated correctly. The interior wall of the clarifier was uniformly pitted to a depth of 1/8 in. (3mm), and rust had penetrated to a depth of 1/4 in. (6mm) in the water collection trough. Stratified rust, measuring 1/4 (6mm) to 3/4 in. (18mm) thick, covered the interior walls. Once cleaned, the surface appeared to be scalloped, as if a spoon had been drawn along the surface, creating depressions in which pitting had occurred, in some places penetrating through the tank walls.

Raw Water Clarifier Tank Prior to Surface Prep

The proposed fix involved the application of fiber reinforced structural epoxies to fill the pitted area. The cured structural epoxies have structural values the same as aluminum. To ready the interior of the clarifier for coating, the contractor removed the existing rust and prepared the surface to an SSPC-SP 5, white metal finish with a 4-mil profile by abrasive blasting. The tank was then washed down with power washers at 2,000 psi. The interior was allowed to dry overnight. Workers removed flash rusting and

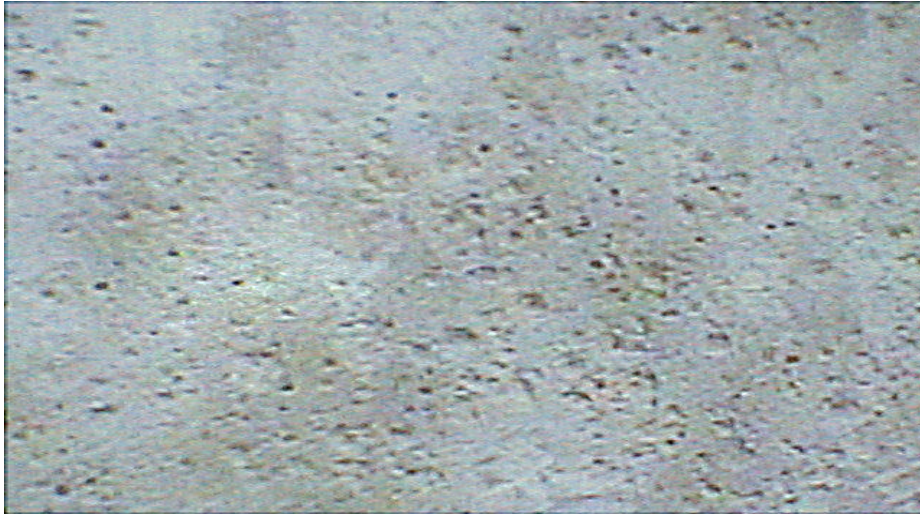
Near white metal blast of clarifier walls

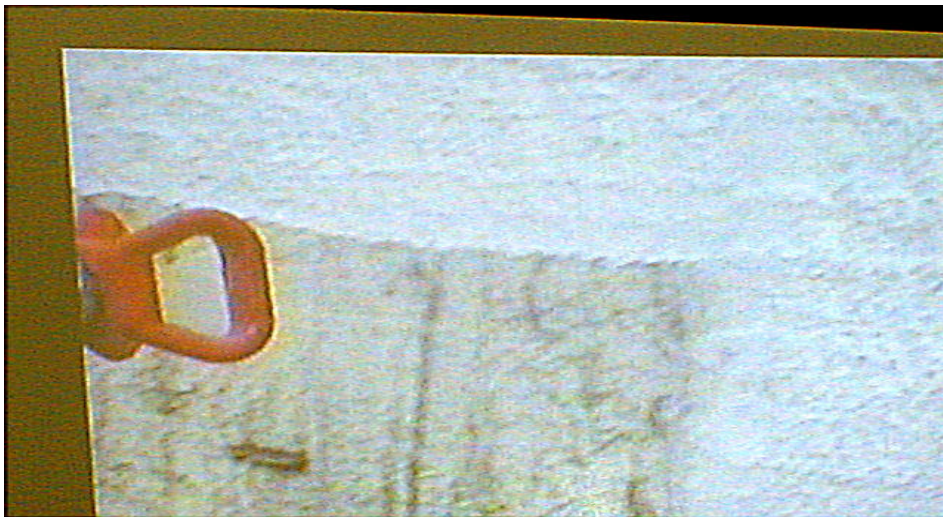
Spray application FRP

After blowing down the interior walls, the contractor applied 20 mils (500 micrometers) of a structural epoxy primer. An intermediate coat of fiber reinforced structural epoxy was applied at a thickness of 1/4 in. (6 mm) and struck with a trowel. The topcoat, a third formulation of cycloaliphatic epoxy, measured 80 mils (2 mm) and was applied via plural component airless spray.

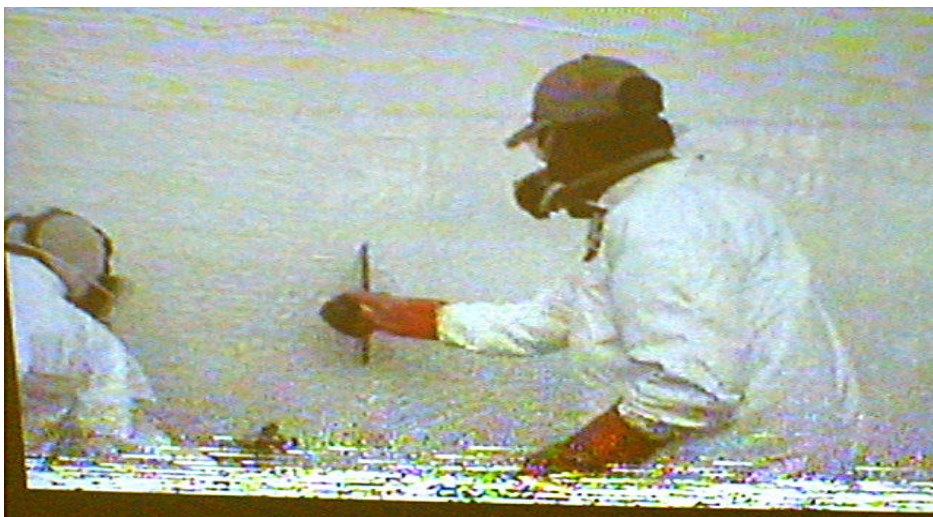
Finishing FRP

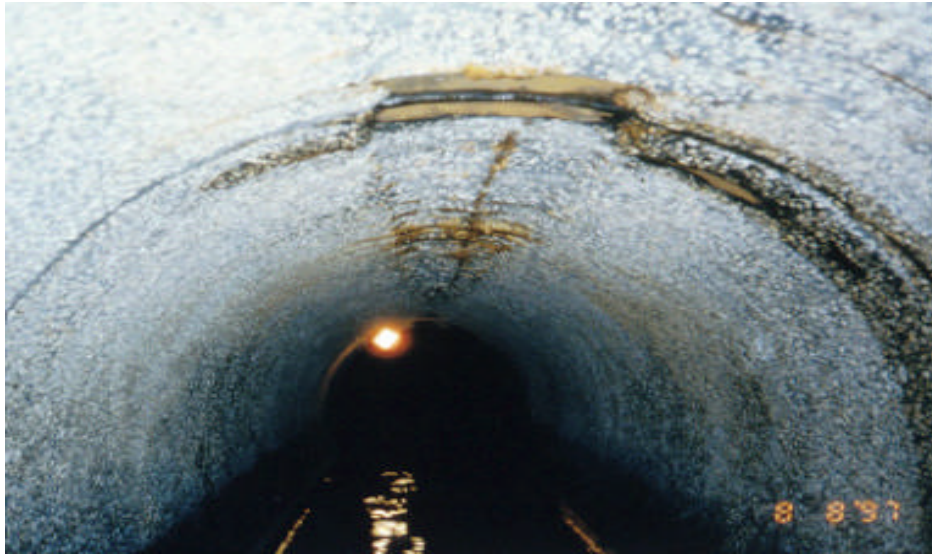
This project consisted of deteriorated raw sewer transition vaults made of cast in place concrete and 240' of 60" wastewater conduits made up of reinforced concrete pipe. The vaults and the pipe had been badly deteriorated by H₂S and other sewer gases. In some places the earth was exposed on the top 1/3 of the pipe and the vaults. Due to the design of the sewer system and the narrow streets in this area, bypass pumping was not an option. The configuration of the sewer line and the tie-ins with the transfer vaults cancelled out the possibility of using a slip line product. The city was faced with a major open cut sewer replacement project in a heavily congested business district. If they used conventional construction replacement methods, many restaurants and shops would be out of business during the construction operation.

Surface prep of 60" RCP

Once the safety system was in place, the 60" pipe and the two structures were prepared for relining by high pressure water blasting and sand blasting. All heavy cleaning was done prior to the start of any lining. All deteriorated rebar was replaced. Once all surface prep was completed, the relining project began.

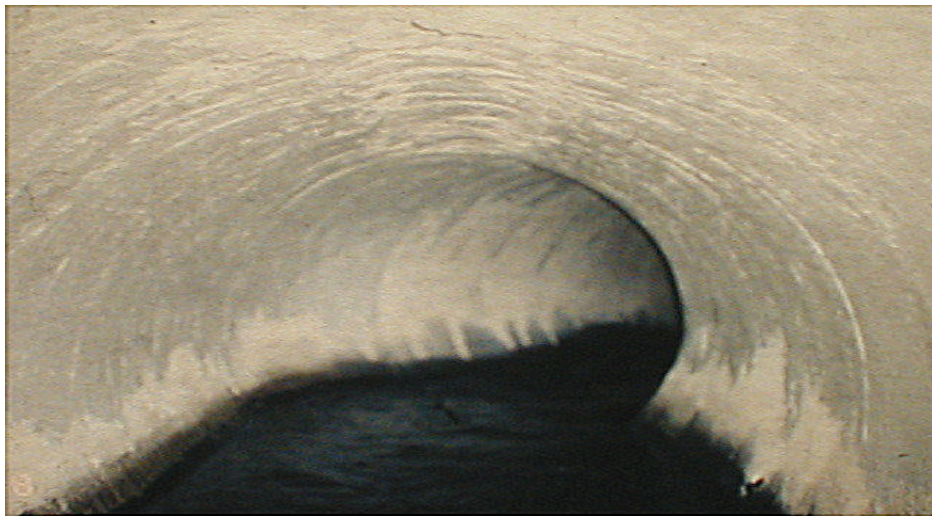
Completed structural epoxy restoration of 60" RCP

The top half of the tunnel was sprayed with a penetrating primer at 180°F. Once the primer had cured, approximately one hour, the heavily deteriorated areas were filled with a structural epoxy fortified with chopped e-glass and crushed ceramic particulite. The e-glass was used to improve ductility and the ceramic particulite was used to serve as a heat sink to improve curing characteristics. Once the fortified epoxy surface restoration system had been applied, the entire surface was sprayed with 150 mils of structural epoxy.

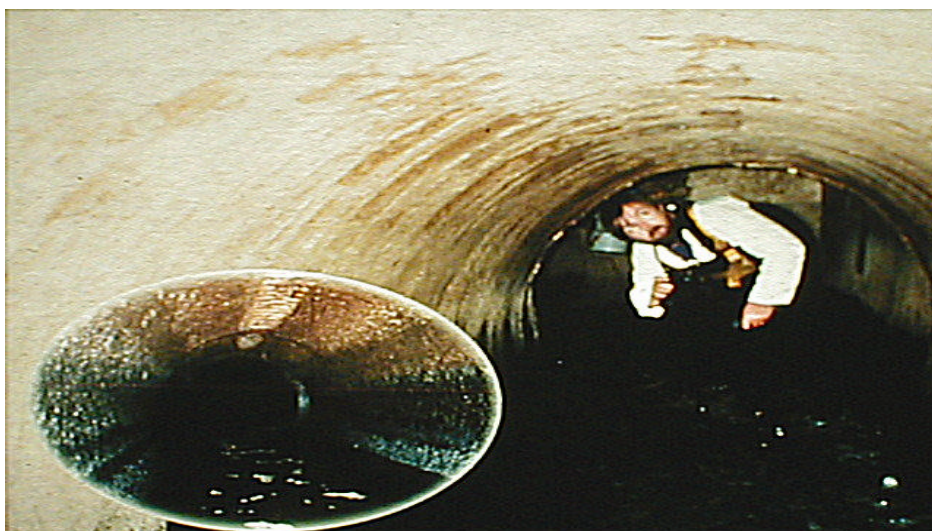
The project was completed in July of 1997 and re-inspected in 1998 and 1999. The 1999 inspection was conducted by the City and David Leyland of KTA-Tator. The project was inspected again in 2002. There has been no sign of further corrosion, infiltration, or delamination of the liner in the 5-year time span.

Two-year inspection performed by KTA Tator showing no sign of further corrosion

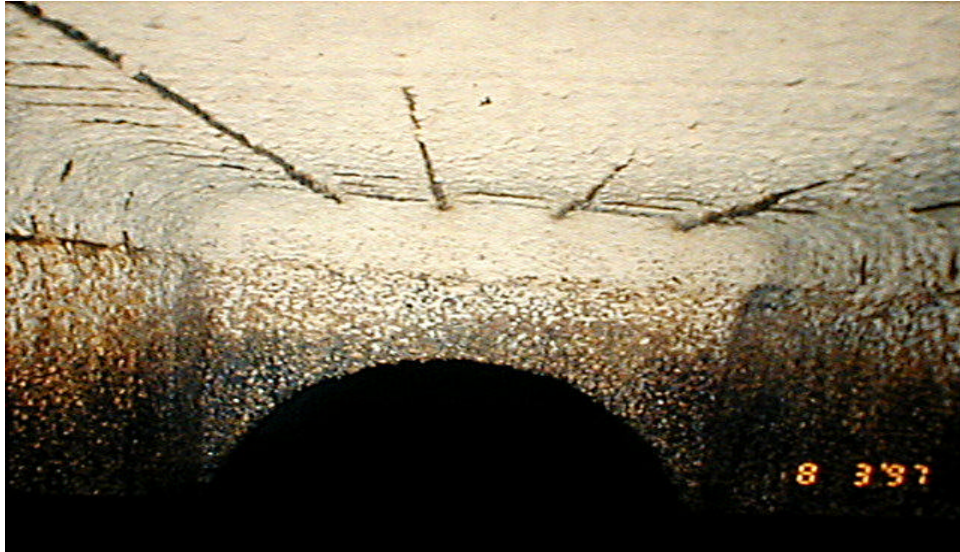
Chamber 1 – Surface Prep – Miami Dade, FL

The sewer transition vaults were successfully restored to full structural value by removing all spent concrete and acid attacked mortars via 10,000psi water blasting and sand blasting. Deteriorated rebar was replaced and welded into place in Chamber #1 and Chamber #2. In some places hydrogen sulfide had destroyed all the concrete back to the earth. The ceiling was repaired with a structural epoxy fortified with chopped e-glass and crushed ceramic particulite. The e-glass was used to improve ductility and the ceramic particulite was used to serve as a heat sink to improve curing characteristics. Once the fortified epoxy surface restoration system had been applied, the entire surface was sprayed with 150mils of structural epoxy.

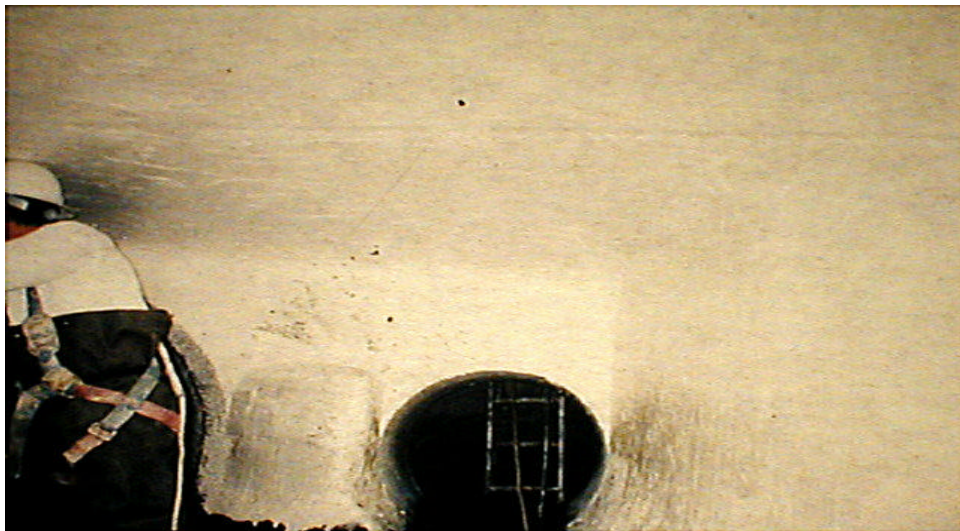
Chamber 1 – Completed - Miami Dade, FL

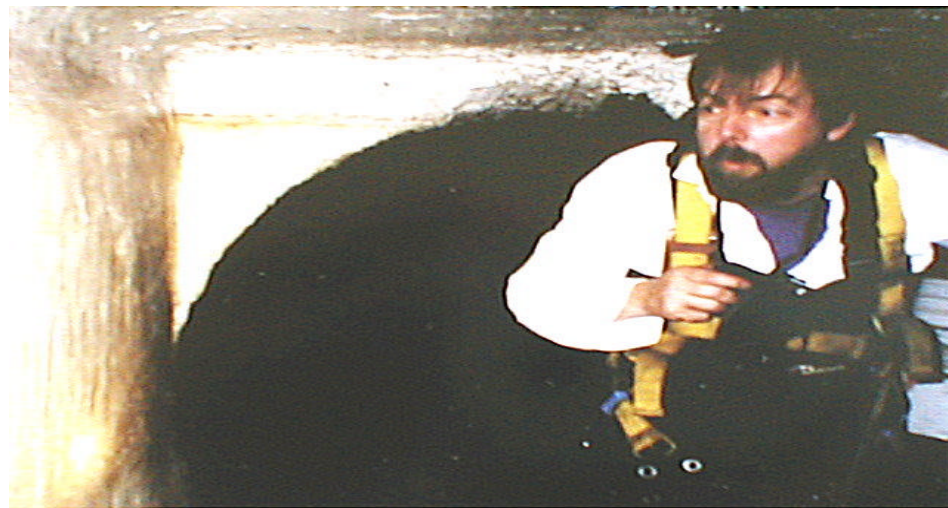
Chamber 1 – Two Year Inspection showing no sign of corrosion

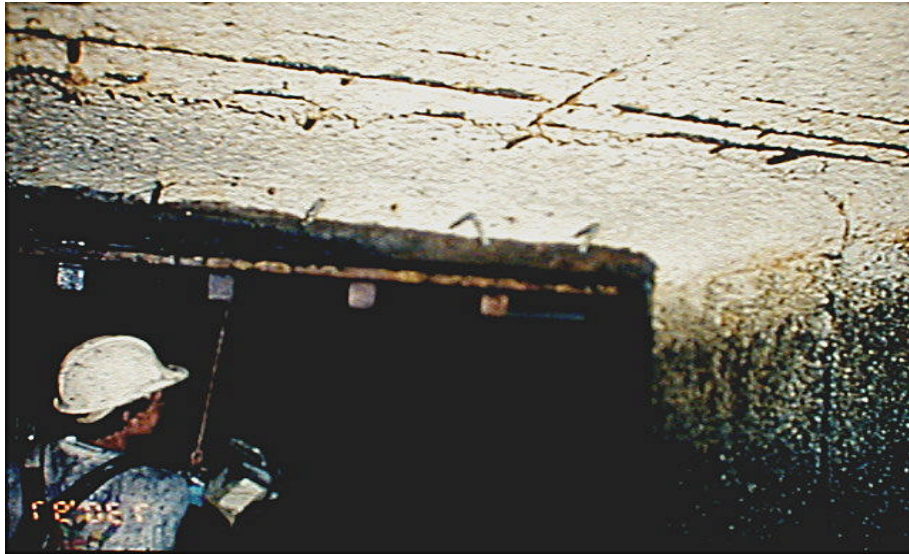
Main pump station collection chamber – Surface prep

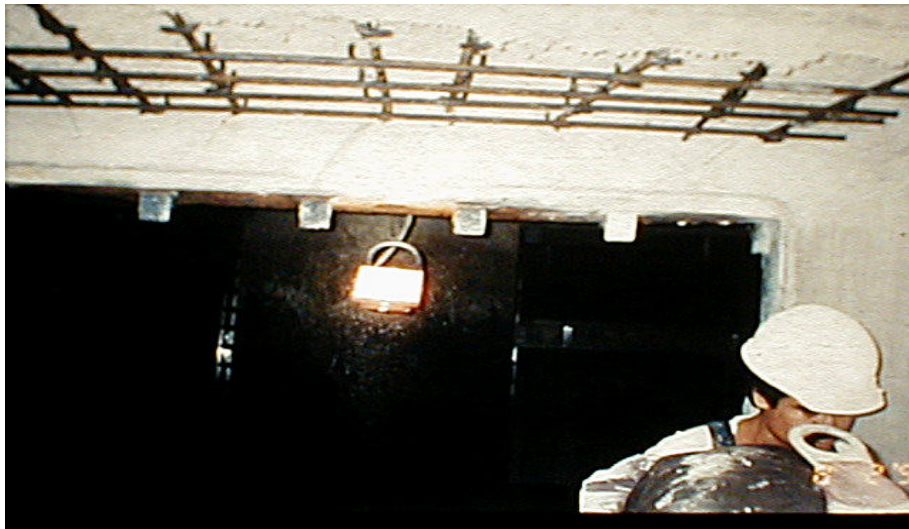
Installation of new rebar where original rebar and concrete substrate had deteriorated back to the earth

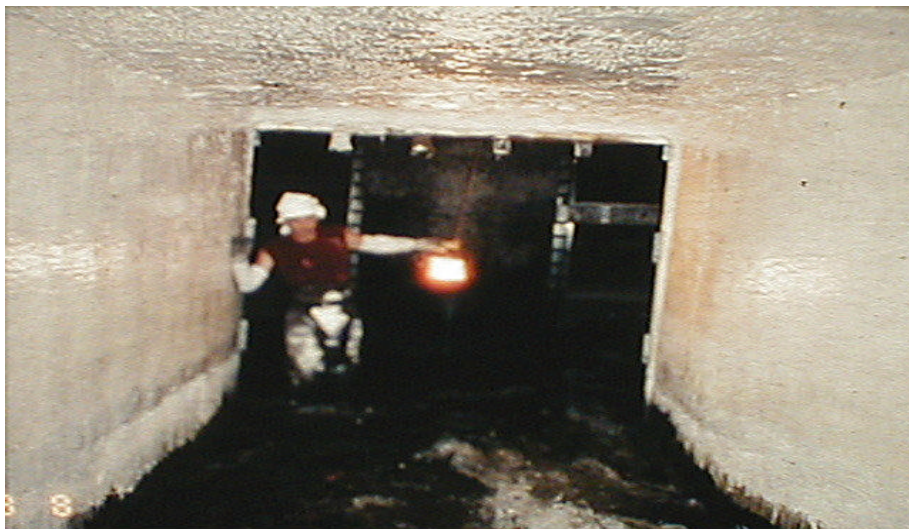
Chlorine washed and power washed prior to two-year inspection – Miami Dade, FL

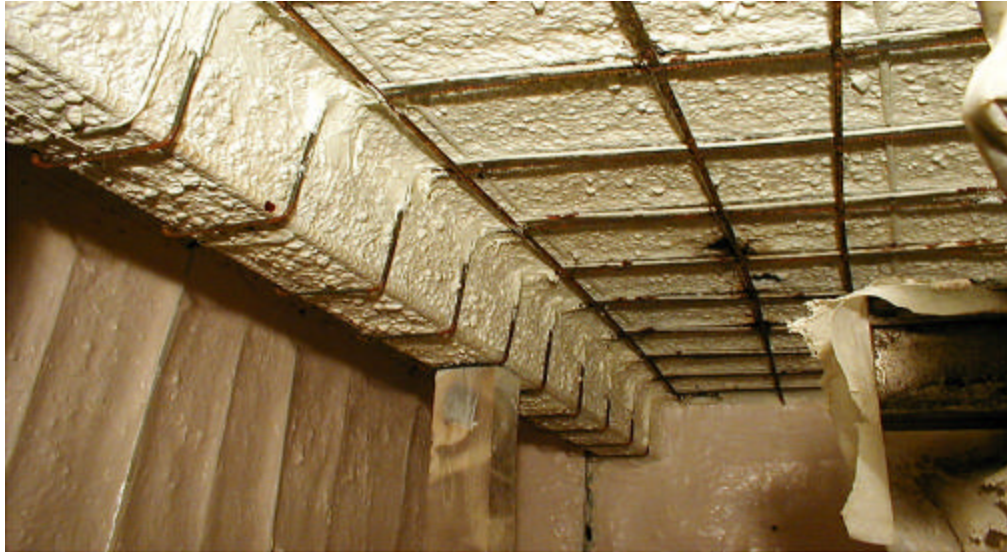
During a corrosion inspection in 1998, the brewery found extensive corrosion in their main wastewater collection tanks. The plant was facing a forced shut down of 2-3 months due to the extensive damage in the main wastewater collecting tanks. The corrosive effect of wastewater, with a ph of 3-4, and the abrasive effects of the crushed glass in the wastewater collection system had corroded and eroded the concrete walls and floor back to and beyond the rebar.

Wastewater collection tank – cast in place concrete

The restoration project was delayed 8 hours due to problems shutting down the main plant. Once the plant was finally locked out, the project to rebuild the vessels began. The two vessels were prepared for relining with a 10,000psi hydro blast unit with an aggregate media injection system to control the dust and speed up the cleaning process. This surface preparation system completely eliminated dust within the building. Any deteriorated rebar found during the inspection was replaced with new rebar and welded into place. The walls were then primed with a flood coat of penetrating primer at 180°F. Once the primer had cured, approximately one hour, the heavily deteriorated areas were filled with a structural epoxy fortified with chopped e-glass and crushed ceramic particulate. The wall and floor area had been corroded up to 6" deep on over 60% of the holding vessel surface. The e-glass was used to improve ductility. The ceramic particulate was used to serve as a heat sink to improve curing characteristics and avoid cracking of the epoxy restoration system that was applied 2-6" thick to restore the vessel walls, floors and ceiling to the original design. Once the structural value was restored with the fortified epoxy surfacing system, the entire vessel was sprayed with 150 mils of structural epoxy.

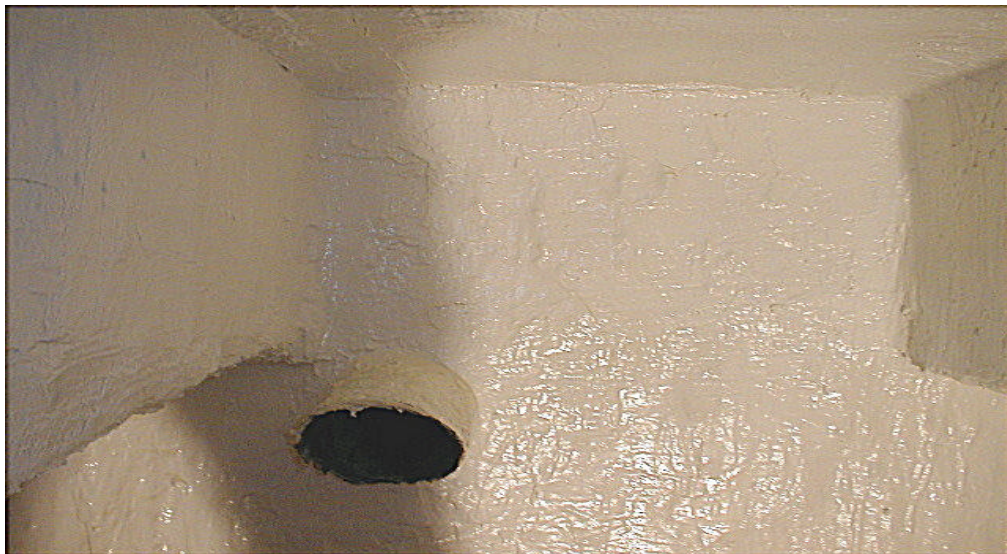
In September of 2002, the two vessels were reinspected. They were found to be in perfect condition by a brewery inspection team.

Structurally restored collection tanks with structural epoxy system
