RE: Structural Testing of Warren Environmental Products

Physical Characteristics of Deteriorated Reinforced Concrete Pipe Repaired with Epoxy Materials

Physical Characteristics of Asbestos Concrete Pipe Repaired with Epoxy Materials

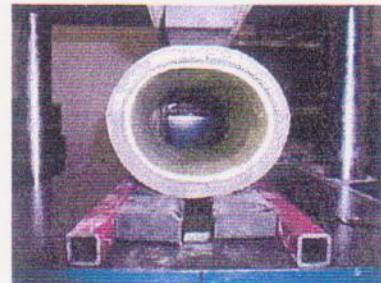
The failure mode of the specimens having a 3/16 inch layer of epoxy on their inside surfaces was very similar. It was observed that the epoxy liner did not appear to be engaged when the pipe failed. No evidence of the damage to the liner was evident at pipe failure. In order to investigate this behavior further, one lined specimen was deformed beyond the point of pipe failure to investigate the ultimate behavior of the epoxy liner. The series of photographs documents this process. It is clear that even following the large deformations, the epoxy lining material remains intact. The residual three edge bearing capacity at this stage is approximately 20% of the ultimate capacity of the lined pipe and about 23% of the ultimate capacity of the unlined pipe.

Failure of pipe (deflection = 0.81")

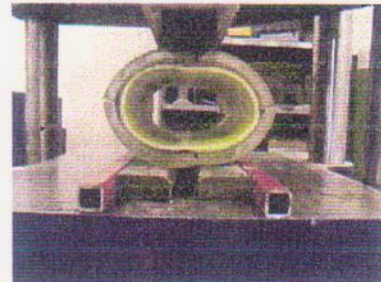
Deflection = 1.39"

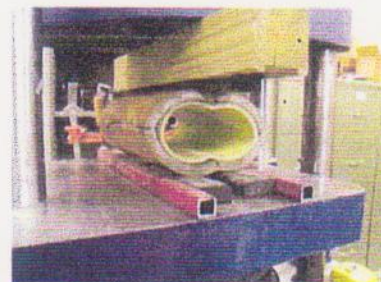
Deflection = 1.79"

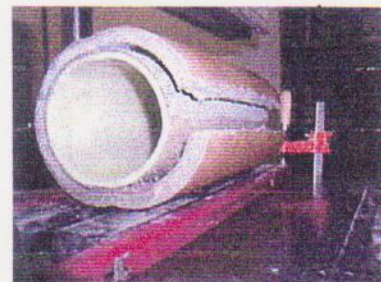
After release of load.
