**Report to Warren Environmental**

# **Hydrostatic Pressure Tests of Spray-Applied Epoxy Lining System**

25 March, 2013

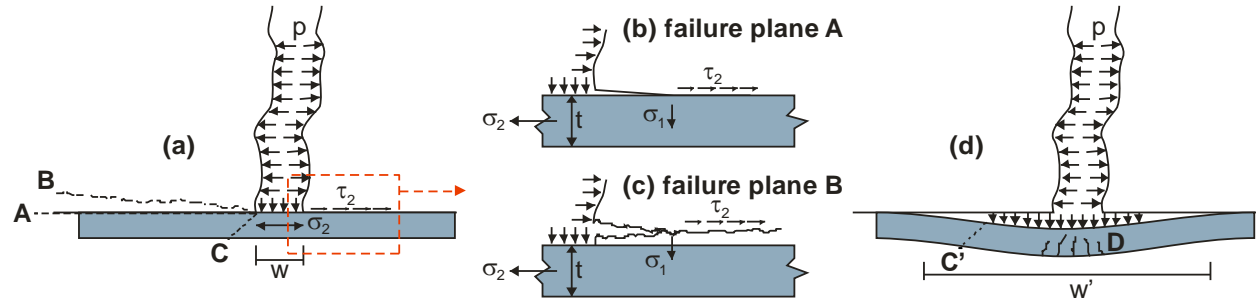
**Figure 1** Conceptual representation of debonding phenomena.

Conceptually, the epoxy bond must be sufficiently robust to resist the ‘wedging’ or ‘prying’ action of the hydrostatic pressure,  $p$  at the concrete-epoxy interface. A simple analogue is shown in Figure 1a, representing a section through a crack having a crack width of  $w$ . At each side of the crack, the hydrostatic pressure results in:

1. a tensile force,  $\sigma_2$ , generated in the epoxy which is transferred to the concrete through Mode II shear stresses,  $\tau_2$ ; and;
2. a Mode I tensile force acting at the epoxy-concrete interface at the edge of the crack resisting the hydrostatic force  $pw/2$ .

These forces result in a complex ‘mixed mode’ stress condition at the epoxy-concrete interface as shown in Figure 1b. Two failure planes may result:

**A:** adhesive failure along the interface (Figures 1a and 1b). This failure path is associated with the *in situ* bond strength of the epoxy.

**B:** cohesive failure in the concrete adjacent the epoxy interface (Figures 1a and 1c). This failure path is associated with the concrete tensile properties.

Experience with epoxy adhesives bonded to concrete indicates that the adhesive bond strength far exceeds the concrete tensile strength; therefore path **B** is more likely. The mixed mode nature of loading (Figure 1c), the *in situ* compressive circumferential stresses resulting from the thick-walled cylinder behaviour of the host pipe, the anticipated tortuous failure path, and additional uncertainties make calculation and/or prediction of this failure mode virtually impossible. For this reason, an experimental study is undertaken to establish empirical behaviour parameters.

Assuming failure initiates, the epoxy (with some substrate concrete attached) will begin to debond/delaminate and the region under pressure will become larger (see Figure 1d for conceptual representation). This will generally be a self-arresting behaviour since as the affected region becomes larger, more concrete is engaged while  $p$  does not increase. Thus there is a critical flaw dimension,  $w'$  beyond which the delamination will not propagate. However, the relatively thin epoxy layer is now a membrane, spanning  $w'$  and supporting the pressure  $p$ . Thus the epoxy may fail in **C'**: shear:

It is informative to discuss the observed data in the context of the mechanics of the problem as described by Figure 1 and in terms of the reported epoxy material properties.

Type I failures correspond to failure surface **C'** shown in Figure 1. The shear stress carried by the epoxy at failure is calculated as:

No evidence of flexural distress (failure surface **D** in Figure 1) of the epoxy was seen in any test. The experimentally observed flexural stress at failure is determined as:

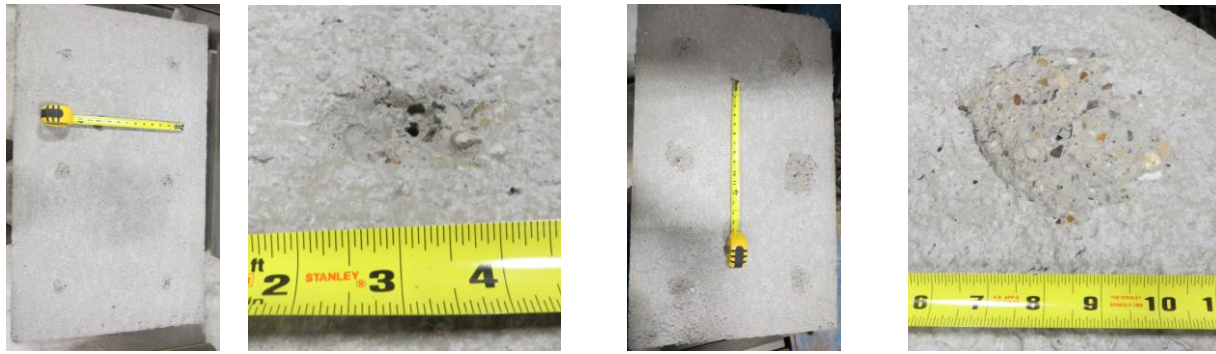
The flaws were created by inserting a flat-bottomed probe through the embedded pipe nipple and 'knocking' the cover concrete out, creating the flaw. In general, the flaws created were 'craters' having a depth  $c$  and sides inclined at a shallow angle of about  $30^\circ$  (shown schematically in Figure 2). Images of typical flaws are provided in Figure 3. The size of each flaw as it is expressed at the concrete surface was measured in the directions parallel to the slab slides. This data is presented in Appendix A.

a)  $c = 0.25$ ;  $w \approx 1.5$

b)  $c = 0.50$ ;  $w \approx 2.5$

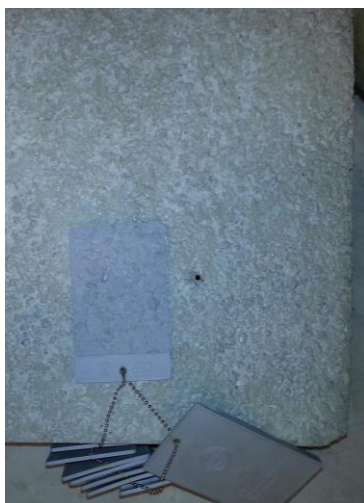
Surface preparation was conducted by A&W Maintenance technicians. Preparation consisted of washing the slab surface with 1.5% muriatic acid solution followed by pressure washing with water at 5500 psi to remove laitance and the very top layer of mortar paste. The resulting slab surface was qualitatively assessed to range from CSP6 to CSP8 using ICRI concrete surface profile (CSP) chips. The slabs (with the exception of 500-15-W1 and W2) were surface dried using a leaf blower resulting in a ‘saturated surface dry’ (SSD) condition at the concrete-epoxy interface. Figure 4a shows the general condition of the slab surfaces prior to epoxy application.

a) surface condition following preparation (CSP8 shown)

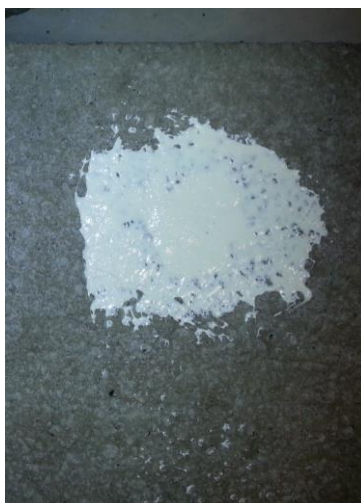
b) mastic-filled flaw

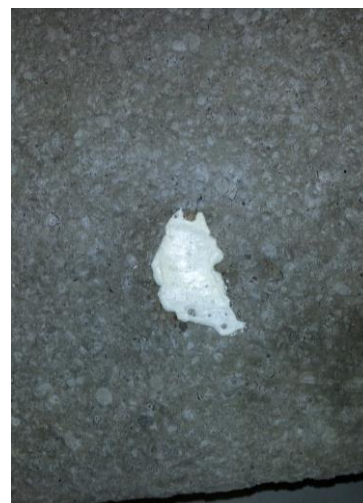
Three additional slabs, labelled 500-xx-V, had a spray-foam<sup>1</sup> plug placed in their flaws prior to epoxy application. The plug was finished flush with the concrete surface and is intended to represent a larger flaw or a flaw at which the epoxy has experienced some degree of debonding. The foam plug does not permit the epoxy to bond to the flaw surface and also results in a larger ‘pocket’ behind the epoxy subject to hydrostatic pressure. Figure 4c shows a foam filled flaw.

c) foam-filled flaw

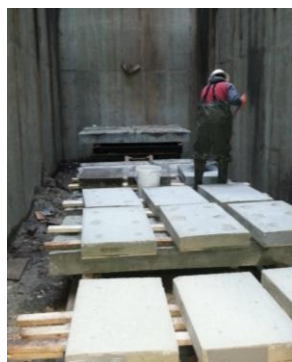
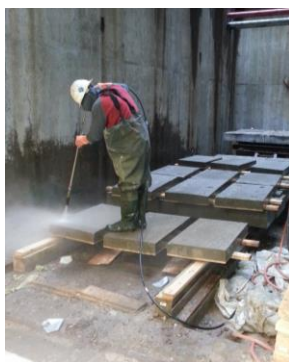
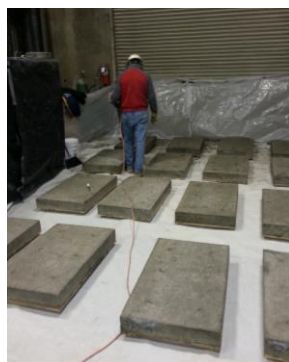
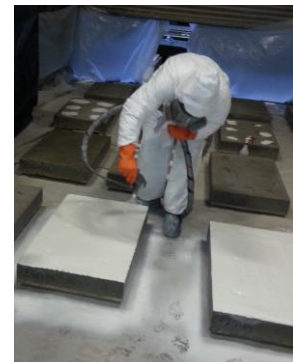
**Figure 5** Epoxy application.

Warren S-301 Epoxy was applied by A&W Maintenance technicians on 14 February 2013; the concrete slabs were 66 days old at this time. Specimens having epoxy thicknesses of 0.125, 0.25 and 0.375 in. (i.e those labelled 125-15, 250-15 and 375-15) were applied in a single coat. All 500-xx specimens had two equal lifts of 0.25 in. each. Specimens 675-15 and 750-15 had initial coats of 0.375 in. and a second coat of 0.25 and 0.375 in., respectively. For all cases with a second coat, this was placed approximately 3 hours and 45 minutes after the first. Ambient conditions during the entire spraying and initial curing were an interior laboratory environment with the temperature approximately 59°F and relative humidity approximately 70%.

a) wash with 1.5% muriatic acid

b) high pressure (5500 psi) water wash

c) surface dry specimens

d) spray application of epoxy

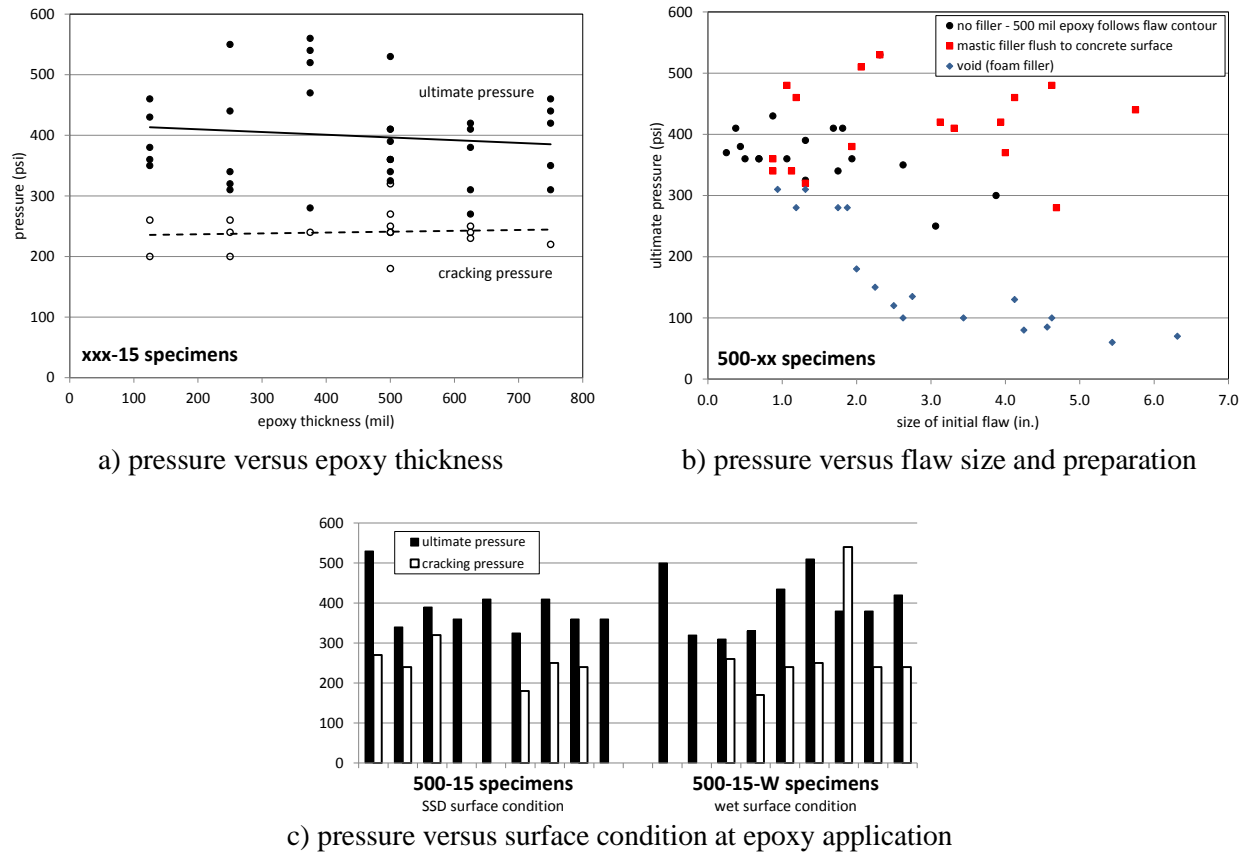
**Figure 7** Hydrostatic test results.

Hydrostatic tests yielded two values of pressure. The ‘cracking’ pressure is the pressure at which the initial cracking of the concrete in the immediate vicinity of the pressure tap appears to occur. This results in the formation of an annular space and an instantaneous (although recoverable) drop in test hydrostatic pressure. As more water is pumped in, the pressure drop is recovered and a further increase in pressure is observed as the annular space is enlarged in an essentially radial manner. The ‘ultimate’ pressure is the highest pressure recorded in the test, typically occurring immediately before failure. Following failure, the epoxy is ‘sounded’ to determine the extent of the annular space formed in each test. Determination of the cracking pressure is based on operator sensitivity to the progression of the test and is very often difficult to identify; for this reason fewer cracking pressures are reported. A summary of cracking and peak pressures attained is provided in Table 3 and data for each test is provided in Appendix A. Views of representative failures are shown in Figure 7.

2. A marginal increase in capacity was observed for specimens having thinner epoxy thickness (Figure 7a); this increase may reflect the 'size effect' with thinner epoxy layers being more consistent and having fewer flaws. No significant effect on ultimate capacity was observed for epoxy thickness up to 750 mil.

4. Larger flaws (in a few cases exceeding 6 in. diameter) first repaired with M-301 mastic behaved marginally better than those in which the epoxy was simply sprayed over the flaw (Figure 7b).

5. No significant difference in ultimate capacities was observed between those specimens sprayed in the saturated-surface dry condition (SSD) and those in which standing water (wet) was present, although the wet specimens did exhibit greater variability (Figure 7c).

6. The specimens having an initial void (500-xx-V) created using spray foam behaved quite poorly and the behaviour degraded with increased flaw size (Figure 7b). During epoxy application some reaction between epoxy and foam, manifest by off-gassing, was observed; the epoxy discoloured in all regions above the foam filler and remained discoloured. It is hypothesized that the foam and epoxy reacted

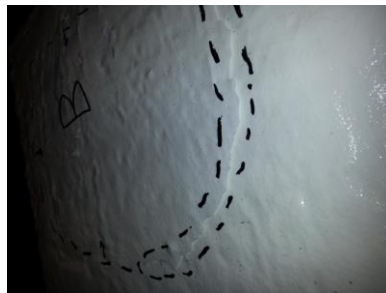
**Failure Type I: Punching Shear Failure of Epoxy.** This failure is believed to be most typical of *in situ* applications where there are no specimen edges. The hydrostatic pressure cracks the concrete in the vicinity of the flaw and water fills in behind the sound epoxy. With increasing pressure, the crack propagates essentially radially from the flaw as shown schematically in Figure 1c along a plane **B** through the concrete immediately adjacent the epoxy. This is a cohesive failure in the substrate concrete. The force behind the epoxy delamination builds with the square of the delamination diameter (area),  $w'$  in Figure 1d, while the resistance of the epoxy is a function of only the diameter (circumference). Thus, eventually, the force behind the epoxy delamination exceeds the shear capacity of the epoxy and a punching failure occurs. This is shown schematically as **C'** in Figure 1d. An example of a Type I punching failure is shown in Figure 8a.

a) Type I punching shear failure

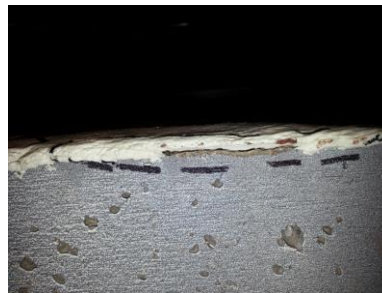
**Failure Type II: Delamination Limited by Specimen Edge.** This failure mode is the same as Type I, although as the delamination diameter,  $w'$ , grows, it reaches the edge of the slab – a radial distance of  $w'/2 = 5$  or 5.5 inches before a punching failure occurs. This failure represents a limitation of the

specimen geometry. In future tests, taps should be placed further from the edges of the slabs and each other. Nonetheless, based on the results observed, Type II failures clearly were approaching the ultimate punching capacity of the specimens and certainly represent sound proof loads. The epoxy shear capacity calculated based on these is a lower-bound value; i.e.: the *in situ* shear capacity of the epoxy exceeds that calculated based on a Type II failure. Representative Type II failures are shown in Figure 8b.

b) Type II failures with delamination expressed at edge of specimen.

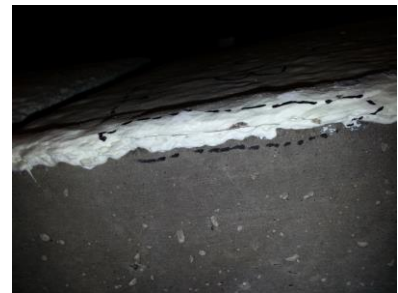
There were a number of instances where Type I and II failures were observed in combination. This is partially an indication that the punching capacity was being reached at the same value of  $w'$  as resulted in the delamination expressing itself at the slab edge.

c) combination of Type I and II failure where punching is observed propagating from location where delamination is expressed at specimen edge.

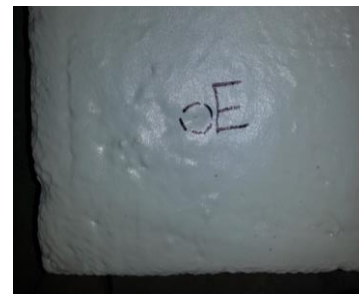
*Failure Type IV: Blow Out.* In this failure, no delamination is noted surrounding the flaw; the hydrostatic pressure simply blows out a small hole in the epoxy. This is represented schematically by C in Figure 1a. This failure was only observed in one specimen (500-40-V-E) and is shown in Figure 8d.

d) Type IV blow out failure.

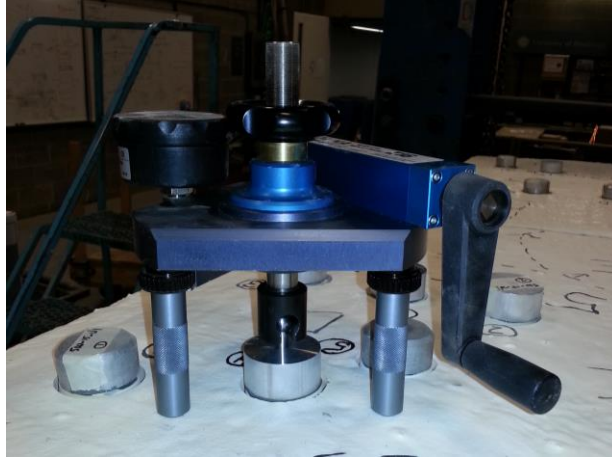
**Figure 9** Dyna Z-15 pull-off test apparatus.

Standard ASTM D7522 pull-off tests were conducted on slabs following hydrostatic testing. A *Dyna Z-15* test apparatus was used for this test as shown in Figure 9. Since the tests were conducted away from the flaw sites only epoxy thickness ( $t$ ) and surface preparation are variables for these tests. The saw-cut used to isolate the test specimen (ASTM D7522) was extended 0.25 in. into the substrate concrete for all tests. A summary of pull-off strengths attained is provided in Table 5 and data for each test is provided in Appendix A. All observed failures were in the concrete substrate immediately below the epoxy application. Failures involved both fracture of aggregate and separation of aggregate from cement paste in approximately equal proportions. Views of representative failures are shown in Figure 10.

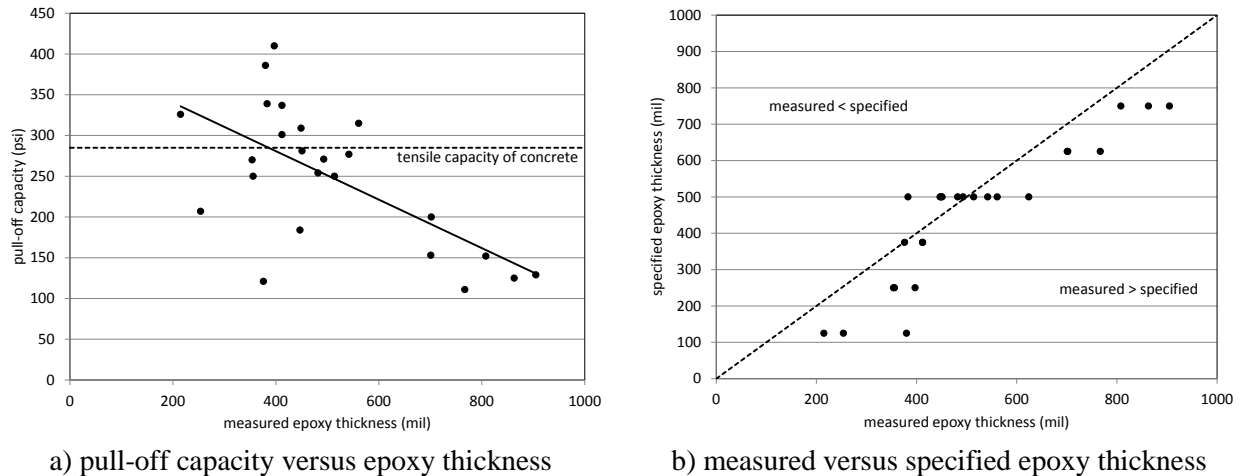
**Figure 11** Pull-off test results.

Considering only the pull-off test results shown in Table 5, the following conclusions are drawn:

11. The assumed concrete tensile strength is approximately 285 psi. The pull-off tests are not expected to exceed this value. Considering variability, specimens having epoxy thickness up to 0.500 inches exhibited pull-off tests results essentially capturing the concrete tensile strength. Thicker applications were apparently weaker, lending support to the hypothesis put forth in the previous conclusion.
12. Generally, the *in situ* epoxy thickness was greater than the specified thickness as shown in Figure 11b. With the exception of the very thin 0.125 in. epoxy application, the variation in thickness was relatively small and the average ratio by which the *in situ* thickness exceeded the specified is shown in Table 5.
