PIPE LINING PRESSURE TEST

Test Performed for: Dan Warren, A&W Maintenance/Warren Environmental
Test Performed at: A&W Maintenance/Warren Environmental, 137 Pine Street, Middleboro, MA 02346
Test Performed: November 21, 2007

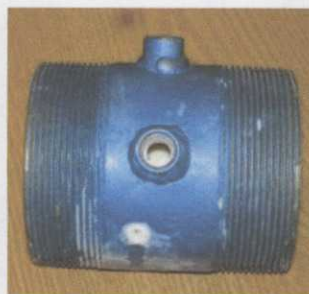
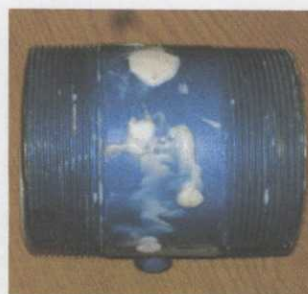
Figure 1 Test Specimens.

The SILVER specimen was lined with a $\frac{1}{4}$ in. (nominal) layer of structural epoxy. The BLUE specimen was lined with a 5/32 in. epoxy impregnated felt liner and interior impermeable membrane. As shown in Figure 1, the uniformity of the BLUE lining was exceptional while the SILVER lining was "off-center" resulting a thicker layer on one side of the pipe and a thinner layer on the other – although the average was $\frac{1}{4}$ in. The lining thickness near the $\frac{3}{4}$ in. hole (failure location as described below) was approximately $\frac{1}{4}$ in.

(a) SILVER Specimen

inlets and $\frac{3}{8}$ in filled hole

$\frac{3}{8}$, $\frac{1}{4}$, $\frac{1}{4}$ and $\frac{3}{4}$ in. filled holes
(b) BLUE specimen

Two specimens, designated SILVER and BLUE were prepared (Figure 1). Both specimens were 4 in. diameter Schedule 40 steel pipe having the properties given in Table 1 (ANSI). Specimens were 4 in. long with an additional approximately 2.5 in. of threaded region at each end to accommodate the end caps necessary for the test.

Specimens were provided with two inlets approximately 60° from each other. Six drill holes were provided around the remaining circumference of the pipe at approximately 42° intervals (i.e.: no holes were provided in the 60° region between the inlets). The hole diameters provided were (in order from one inlet) $\frac{3}{8}$ in., $\frac{1}{4}$ in., $\frac{1}{4}$ in., $\frac{3}{4}$ in., $\frac{1}{4}$ in. and $\frac{3}{8}$ in.

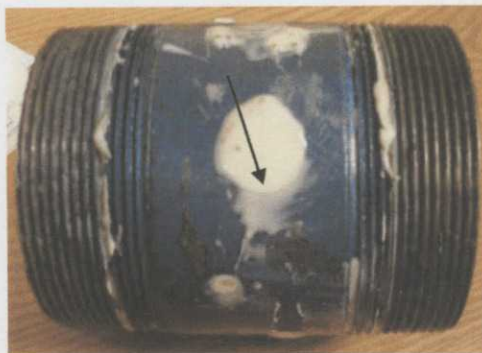
Figure 4 Failure of BLUE Specimen

The BLUE specimen achieved and maintained 2500 psi internal pressure. Following the test, a hairline fracture around the $\frac{3}{4}$ in. hole was noted. This failure, identical to that seen in the SILVER specimen and described below, did

not result in leaking water. The specimen was repressurized to 3000 psi. At this pressure, the "plug" in the $\frac{3}{4}$ in. hole was clearly "pushing out" (Figure 4), however no leak was observed indicating that the interior impermeable liner remained intact.

(a) following initial test to 2500 psi showing hairline crack around edge of $\frac{3}{4}$ in. hole

(b) condition of $\frac{3}{4}$ in. hole while holding 3000 psi internal pressure

"plug" pushing out of $\frac{3}{4}$ in. hole

note that there is no leak despite the internal pressure

If the value of α is taken as unity, the apparent shear capacity of the epoxy system is found as shown in Table 2. It is likely that the shear failure in the BLUE specimen occurred at an internal pressure lower than 2500 psi, although this cannot be confirmed. Based on observations (Figure 4), the failure had not propagated completely around the $\frac{3}{4}$ in. hole at this pressure however.

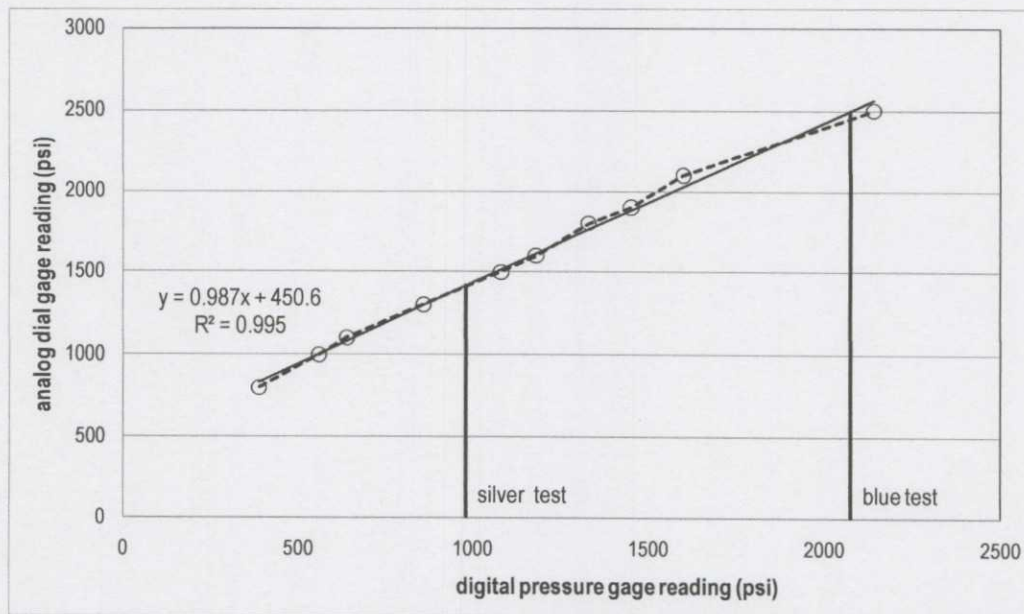
Figure A.1 Digital pressure gage correlation.

During testing it was observed that the digital pressure gage connected to the pump was reading incorrectly. The analog dial gage connected directly to the test specimen is believed to yield correct readings. To assess the correction necessary to correlate the digital and analog readings a simple calibration was performed. The analog dial gage was connected in parallel with the digital pressure gage and readings were taken. Figure A.1 shows this correlation between readings. Over the range of actual pressure (analog dial gage) greater than 500 psi, the correlation is linear with an R^2 coefficient greater than 0.99. The correction is as follows:

$$\text{actual pressure} = 0.987(\text{digital reading}) + 450.6 \text{ [psi]}$$

Thus the actual pressure determined for the SILVER test is: $0.987(980) + 450.6 = 1418$ psi. This value is reported. This need for correction was identified prior to testing the BLUE specimen and the dial gage readings were used directly in this case.
