Comparison of Effectiveness of Repair Systems between RC Beams Repaired with Sprayed Fiber Reinforced Polymer and Fiber Reinforced Mortar

Cement & Concrete Composites, submitted for possible publication.

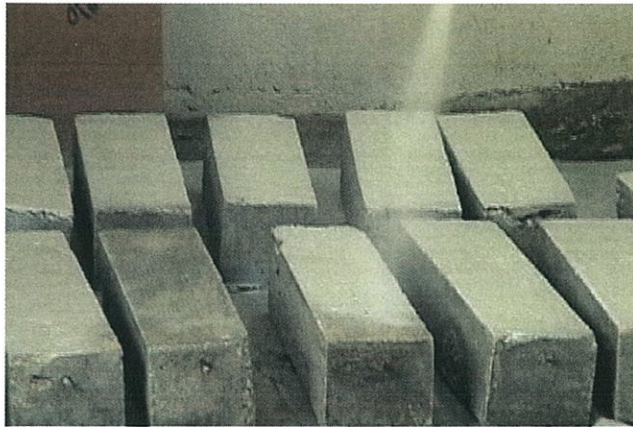
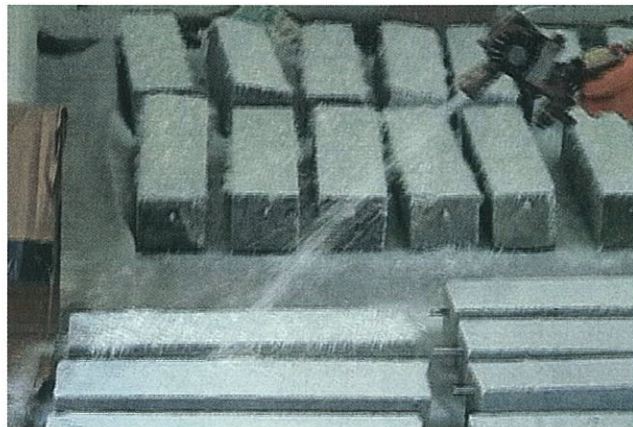
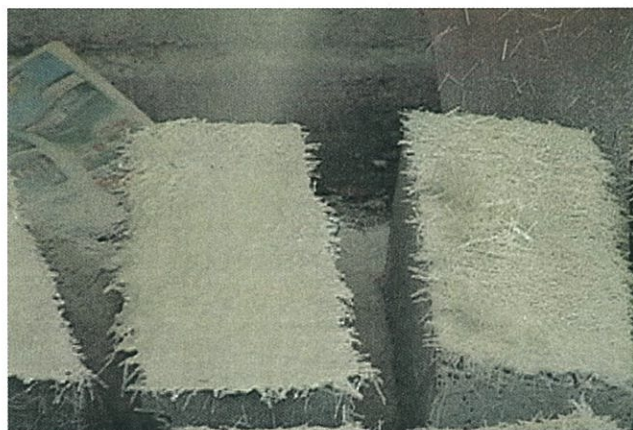
(a) Epoxy resin base coat

(b) Fiber application

(c) Epoxy resin top coat

Figure 1. Application of SFRP.

An initial thin layer without fibers is sprayed through a standard spray gun (Figure 1 (a)). This layer acts as a base for the remaining layers, creating a consistent bond with the specimen and completely coating the application face. Any large cracks on the application surface can be filled during spraying of this layer. The fibers are sprayed on next through a pneumatic powered chopping spray gun (Figure 1 (b)). This gun consists of a rotary chopper with blades placed radially. With all blades installed, the fiber length is 13 mm; with every other blade removed, the fiber length is 26 mm and so on. For this research, the fibers were applied at 13 mm length and fifteen percent by volume. There are two rubber wheels that spin and pull the fiber through the gun. The fibers used in this study were a multi-filament E-glass strand roving. The epoxy resin is provided as two separate liquids, the epoxy resin and a catalyst. All available engineering data for the epoxy resin and the E-glass fibers can be taken from Lee et al. (2003). After application of the fibers, the epoxy resin is sprayed on to completely coat the fibers (Figure 1 (c)). The final thickness of the layer was measured to be 3.2 mm. Once coated, the repaired specimens were left to set for a minimum of two weeks.

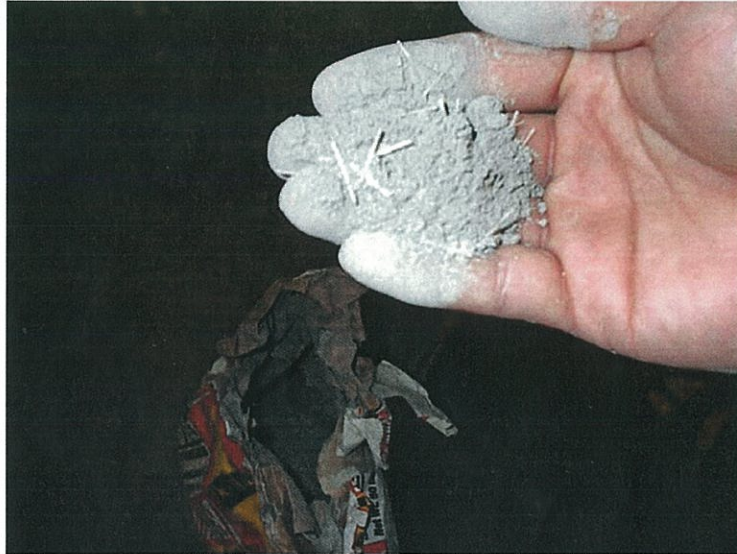
Figure 2. Premixed cement containing the fibers.

The specimens that would be coated with FRM were removed from the humidity room after 105 days and the mortar was applied. Application of the FRM was relatively simple compared to the SFRP. A fifty pound premixed sack of surface bonding cement was used (Figure 2). The premixed cement contains the fibers, Type I Portland cement, lime, sand, and special additives. The volume fraction of the fibers was measured to be roughly 5% (Figure 3). Exact amounts of each ingredient and types of fibers cannot be reported as they are considered proprietary. First, the specimens were prepared for application by wiping

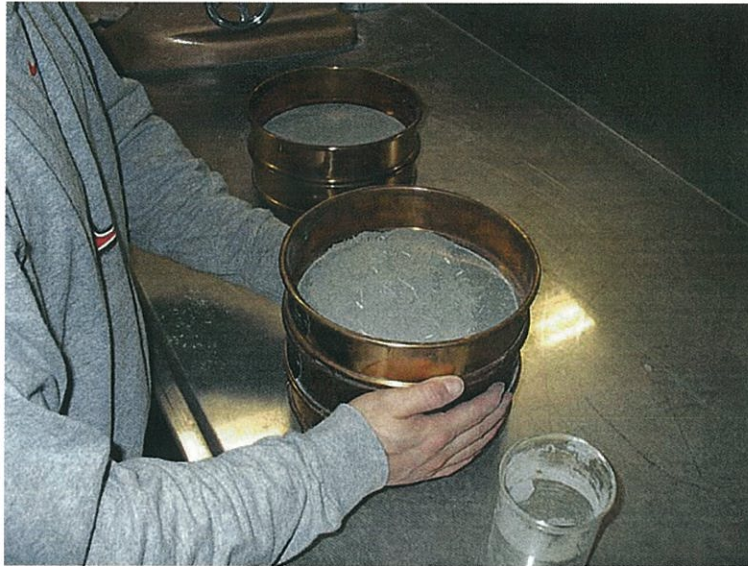
Figure 3. Estimation of volume fraction of fibers using sieve analysis.

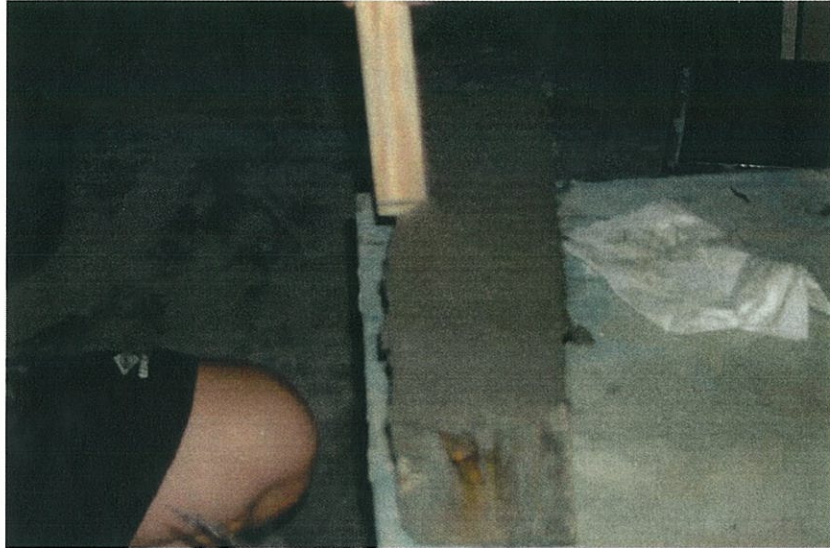
Figure 5. Measurement of thickness of the mortar coating.

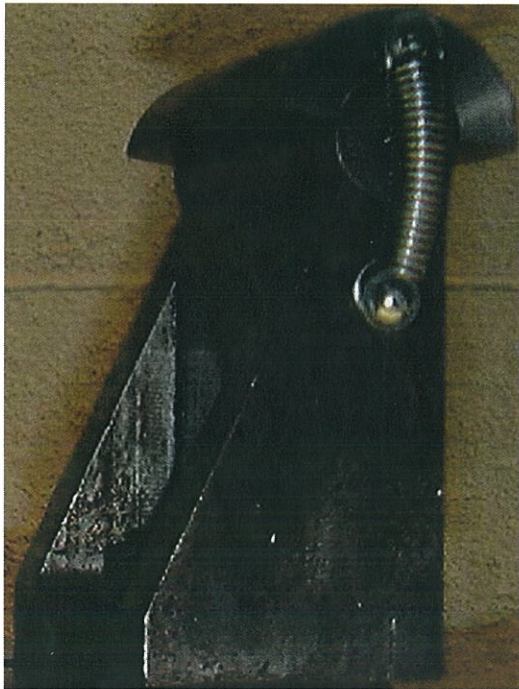
Figure 6. Support blocks: (a) Loading base with rod (left); (b) Loading base with ball (right).

Two spherically shaped blocks with an outside diameter of 50 mm (2") support the specimen. One support block is supported on a rod of the same length as the block (Figure 6 (a)); the other support block is supported on a ball of 9.5 mm (3/8") diameter at its midpoint (Figure 6 (b)). The load is applied with a spherically shaped loading block with an outside diameter of 50 mm (2"). The load is applied at the midpoint for the beam. A rubber bearing pad of 3.2 mm (1/8") thickness is used at each block to ensure even loading along the contact surface.

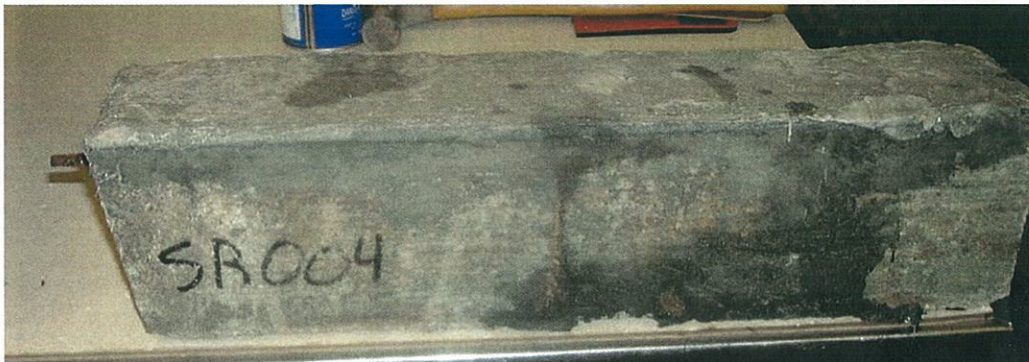
(a) SFRP

(b) FRM

Figure 12. Repaired Specimens: (a) SFRP; (b) FRM (Note that the repair system is only applied to the tension face, allowing for intrusion of corrosive materials from the side faces.).

While neither of these repair systems would stop intrusion into the specimen of water or other corrosive materials (Figure 12), they do increase the tensile strength of the cracked specimen. Restoring the original strength of the specimen is the first step in repairing the specimen, but for the repair system to be truly effective, it must do more. While the FRM specimens did exceed the original strength of the uncracked specimen, they did so utilizing
