# EVALUATION OF PROTECTIVE COATINGS FOR CONCRETE

December, 2004 Final Report

County Sanitation Districts of Los Angeles County, Whittier, California

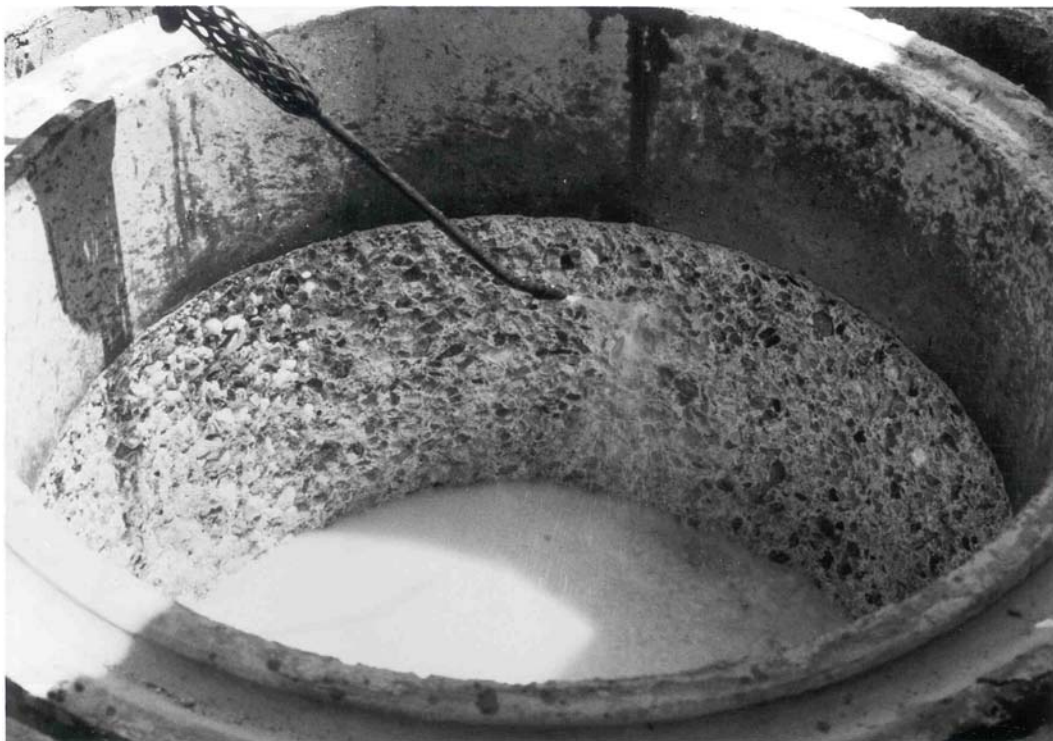
The lower half of each tank was allowed to corrode for six to eight weeks, using 265 liters (70 gallons) of a 10% (by weight) solution of sulfuric acid. Approximately 25 mm (1 in.) of corrosion was observed to occur in the unprotected concrete tanks during this period. This rate of corrosion is fifteen to twenty times the highest corrosion rate expected in actual service. The use of 10% acid was arbitrary, but it represents a more corrosive environment than the actual service situation. The observed increased corrosion rate was accounted for by concentration and the volume of acid that was exposed to the concrete surface in the test tank. In the test tank, the corroding concrete was flooded by the 10% acid solution. Figure 4 is a photograph of a test tank showing the corroded lower half and uncorroded upper half.

Figure 4. Test tank being waterblasted.

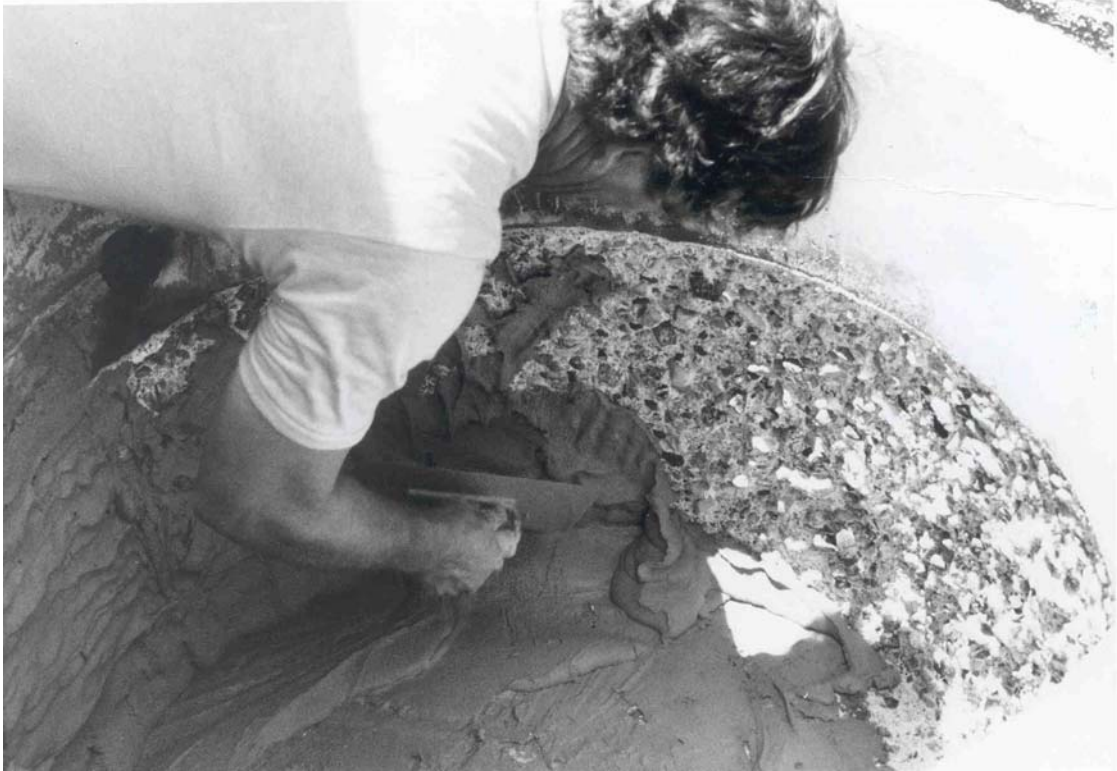
A coating application to the test tank was scheduled when sufficient aggregate and even some reinforcing steel had been exposed. The manufacturer was requested to apply the coating to both the corroded and uncorroded surfaces inside the test tank. The coating manufacturer was responsible for all surface preparation prior to application of the coating. Generally, the manufacturers chose either sandblasting or high-pressure water blasting for surface preparation. Water blasting is illustrated in Figure 4. If too much aggregate was exposed for proper application of the coating, then the manufacturer was responsible for surface repair as well. Most surface repairs used fast curing cements or a mixture of the coating material and an inert filler, such as sand. The entire application process, including surface preparation, had to be completed within 8 hours. Figure 5 shows surface repair work in progress on a test tank. The spray application of a coating is illustrated in Figure 6.

Figure 5. Surface repair to the corroded portion of the test tank.
